Final
Cultural Landscape Report
Volume 2

Pahaquarry Copper Mine
DELAWARE WATER GAP

National Recreation Area • New Jersey

August 1995

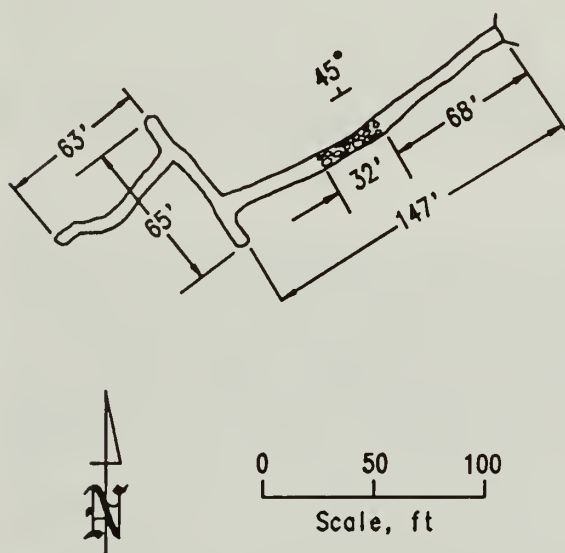
Figure 2. Mine Tunnel No. 1.

During the field investigation, the USBM filmed both mine tunnels and portal areas. Additionally, still pictures of the area are included in the Appendix D of the report to increase the readers' understanding of the rock structure and condition at the site. The approximate dimensions and configurations of Mine Tunnels No. 1 and No. 2 are shown in figures 2 and 3.

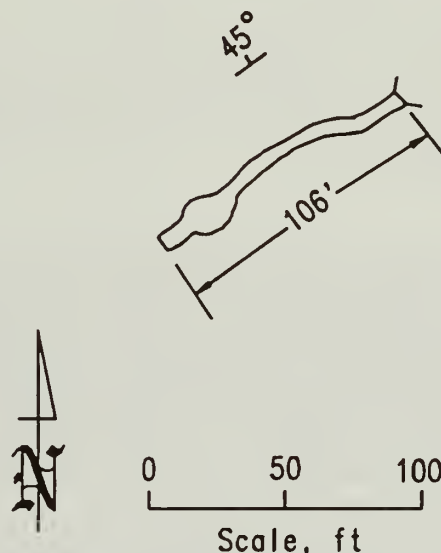
Figure 3. Mine Tunnel No. 2

Immediately behind the wooden door, there is a block of rock that extends down 2 ft below the surrounding roof (Appendix D, photograph 5). The block is isolated by the vertical fracture, partially hidden by the wood door and an additional vertical fracture located 3 ft deeper into the tunnel. The block is also exposed at the bedding, near the low sidewall. However, the block is well keyed into the high sidewall and firmly attached to the roof. This is the largest exposed block of rock in the tunnel with dimensions of 2 ft by 2 ft by 3 ft. At the present time, this block is more of an inconvenience than a major hazard. The block makes it difficult to get in and out of the door because of the low clearance. There are several other large open vertical fractures that are formed perpendicular to the tunnel in the first 20 ft. These fractures give this section an appearance of being loose. These fractures do

From 20 to 40 ft there are no large open vertical fractures. The tunnel roof is stable with very little loose material forming. From 40 to 80 ft the roof follows along a bedding plane in the hanging wall that may be the same shale beds that form the roof in the Mine Tunnel No. 1 (Appendix D, photographs 7 and 8). From 80 ft to the end of the tunnel, the roof is approximately 2 ft lower but still follows the same bedding. The roof is stable under these layers with small amounts of loose material forming along the roof or sidewalls.

From 20 ft to the end of the tunnel only a small amount of material has spalled from the sidewalls and roof (Appendix D, photograph 7). This is an indication of the stability. In the first 20 feet more material has spalled, covering the floor with a few inches of material.

When compared to Mine Tunnel No. 1, there is very little spalled material on the floor of Mine Tunnel No. 2. It is estimated that approximately 20 ft³ of spalled material, most of it occurring in the first 20 ft of the tunnel. However, the material should be placed to one side or removed to minimize the possibilities of tripping hazards and assist with the drainage of any accumulated water. If the material is removed it would make it easier to identify any subsequent roof or sidewall spalls.

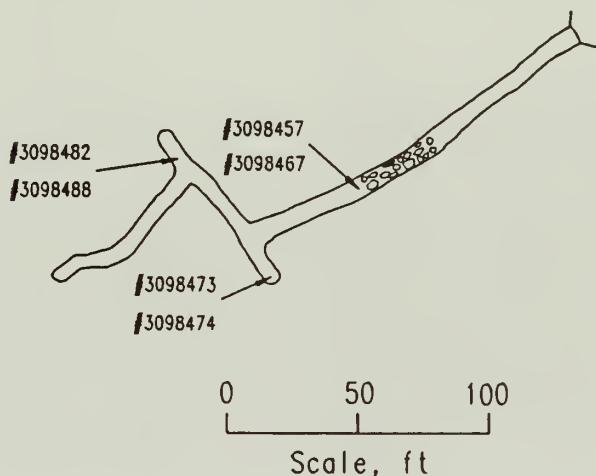
Figure 4. Radon detector locations in Mine Tunnel No. 1.

Ten radon gas detectors were set along the roof of Tunnels 1 and 2 for a period of 30 days (3/9/93-4/8/93). As a control, the detectors were placed in pairs with six detectors in Tunnel 1 and four in Tunnel 2. The locations of the detectors are shown on figures 4 and 5.

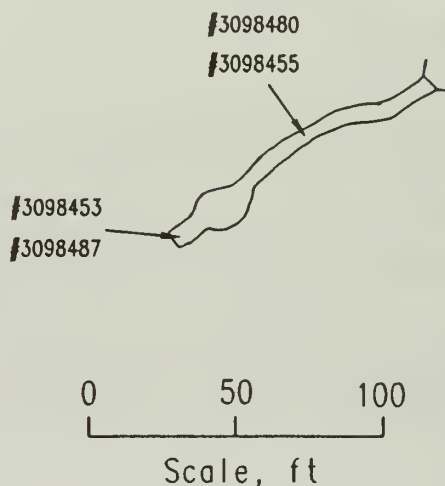
Figure 5. Radon detector locations in Mine Tunnel No. 2.

The test results are given in table 3 with the average radon concentration in picocuries per liter (pCi/L) being the values of interest. The paired detectors in Tunnel 1 give consistent results with the measurements 100 ft from the portal of 189.2 and 174.7 pCi/L, in the crosscut 44.4 and 41.7 pCi/L, and in the crosscut near the back tunnel of 52.8 and 44.7 pCi/L. All the measurements in Tunnel 2 show nearly the identical values with one another. To determine potential exposure to radon daughters (radioactive radon decay products), the average radon gas concentration must be converted to a working level (WL), which is calculated by dividing the average radon gas concentration by 100 then multiplying by a number ranging from 0.2 to 0.8 to provide an estimate of the radon daughter level or WL. In well-ventilated mines the factor can be as low as 0.2; whereas in poorly ventilated mines the factor can be up to 0.8. The tunnels, both with unventilated dead ends, were subject to only natural ventilation during the test period. Because of these existing conditions the tunnels are probably not well ventilated, though the amount of air exchange during the test period is not known. For Tunnel 1, the estimated radon daughter level could range from 0.38 to 1.5 WL for the 189.2 pCi/L measurement and from 0.08 to 0.33 WL for the 41.7 pCi/L measurement. The highest measurements are near the vertical fracture zone where the roof failures have developed. For Tunnel 2, the highest radon gas measurement of 5 pCi/L could result in a radon daughter level of 0.01 to 0.04 WL.

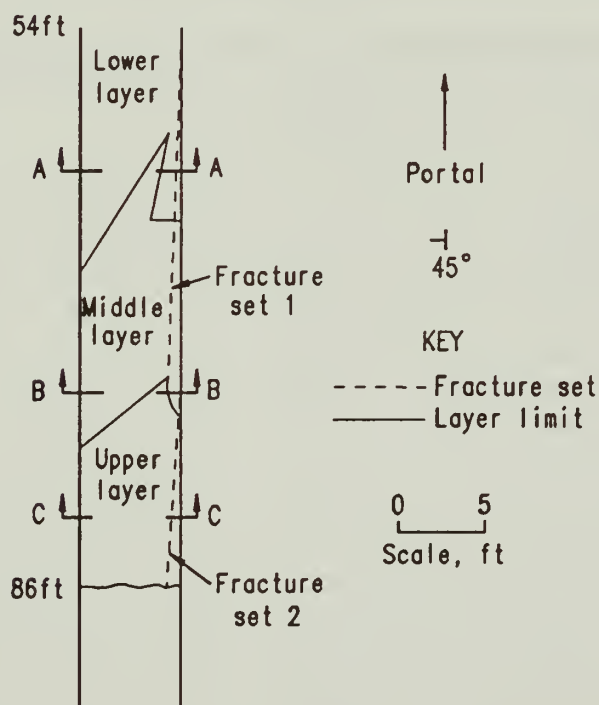
Figure 6. Plan view of the layer boundaries in Mine Tunnel No. 1.

From 110 ft to the crosscut, the roof is formed under the shale beds; however, the tunnel is narrower, exposing less of the hanging wall. More rock was left along the

low sidewall, whereas the high sidewall is lower. The roof appears to be competent with only a small amount of material having spalled from the roof and sidewalls, an indication of stability. The roof in the crosscut and the back tunnel also appear stable, with no signs of any major roof problems. A small amount of water was dripping from the roof near the junction of the crosscut and the back tunnel.

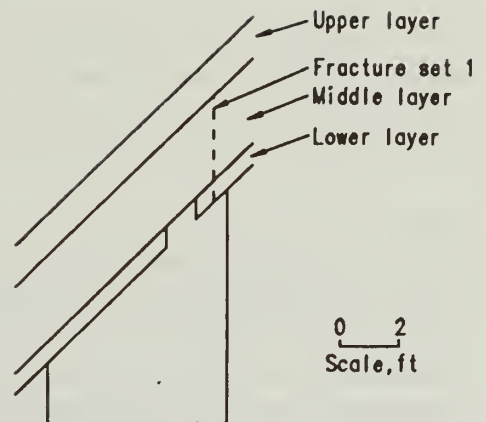
Figure 7. Cross section A-A.

near the high sidewall (vertical wall on either side of the tunnel). In this same zone, there are three main layers: a lower, middle, and upper layer exposed by the spalling or failure of the roof (appendix D, photographs 4-8, 10). Figure 6 shows a plan view of the layer boundaries and the two main vertical fracture sets, and figures 7, 8, and 9 show cross sections taken at A-A, B-B, and C-C. The lower layer is 4 to 6 in thick, the middle layer 20 to 24 in thick, and the upper layer 10 to 12 in thick. Each fracture set is a zone 8 to 10 in wide containing four to six vertical fractures. The first fracture set extends from 54 to 74 ft and cuts across the lower and middle layers but does not appear in the exposed section of the upper layer. The second fracture set extends from 74 to 86 ft and cuts across the middle and upper layers but does not penetrate the overlying roof. A small amount of water was dripping from the second fracture set. The upper layer appears to be solid, even near the fracture. For the middle layer, there was loose material along the exposed vertical edge even though the layer was solid near the first fracture set. The immediate hazard is the small block that extends between the two fracture sets on the high side of the tunnel as shown in cross section B-B. For the lower layer, there is a small slab that extends out along the first fracture that may present a hazard, although it was solidly attached to the roof. There are also single fractures that cut across the roof at various angles. One set of fractures cuts across the tunnel at an angle of about 30° toward the portal from the high to low side. The first fracture is at 52 ft and extends about 3 ft across the lower layer. The second fracture, at approximately 60 ft, penetrates the lower layer into the middle layer crossing the entire tunnel width. A third fracture, at about 66 ft, penetrates the lower and middle layers but extends only 3 ft across the tunnel. From 86 to 110 ft the three layers have either fallen naturally or been manually brought down. The roof has stabilized in the overlying sandstone, which appears to be competent. Neither fracture set appears to have penetrated into this sandstone.

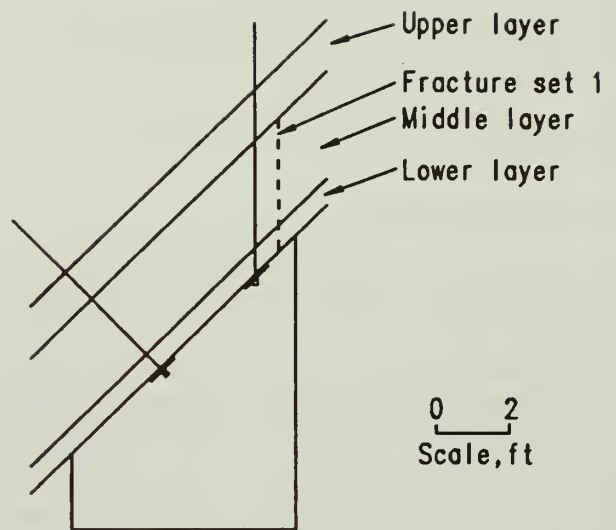
Figure 10. Recommended roof bolt pattern for Mine Tunnel No. 1, side view.

This material will have to be periodically scaled. Wire mesh could be incorporated into the system to prevent the spalling of material but would not increase the stability of the reinforced roof. The mesh would be held tightly against the mine roof with the roof bolts and bearing plates. Spot bolting could be performed between the fractures and the sidewall to minimize roof spalling in this area. This type of reinforcement system, if properly installed, should prevent any large failure of the roof. The visual impact of this system would be the exposure of the bearing plates and the head of the bolts along the roof and the mesh, if used.

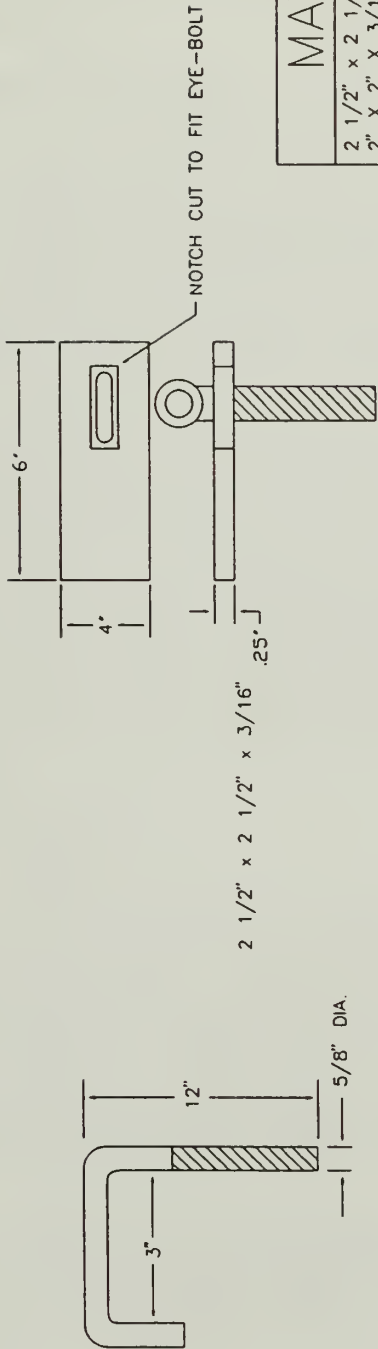
Figure 17. Decline Shaft No. 2 Generic Closure Design

A cliff hangs over the shaft on one end. It may be appropriate to construct a fence with a sign to warn visitors of the inherent dangers associated with falling from the cliff to the mine closure. This in itself will not prevent individuals from climbing out onto the decline shaft closure. The integrity of the closure should be able to withstand live loads associated with visitors climbing onto the structure. The design provided can withstand large live loads.

MATERIALS			
2 1/2" x 2 1/2" x 3/16" CHANNEL	51'		
2" x 2" x 3/16" STRUC. REC. TUBING	120'		
ANCHOR BOLTS	14		
FULL MORTISE HEAVYWEIGHT BALL BEARING HINGE	2

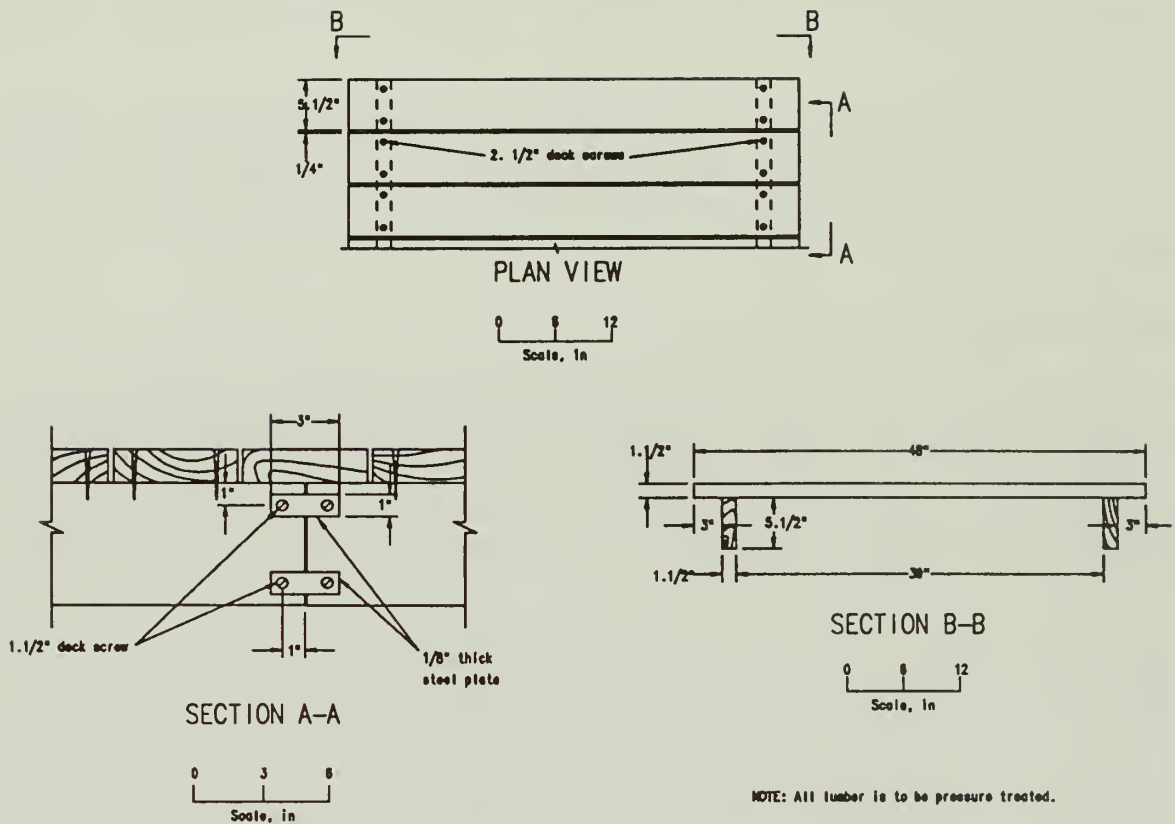
Figure 20. Walkway design for Mine Tunnel No. 1.

The NPS asked that we examine the possibility of creating a wooden walkway in the mine that would keep visitors above the water and reduce the potential for slipping accidents. While a walkway could be constructed of pressure-treated lumber, there are no guarantees that the walkway will not experience wet or moist conditions as a result of the highly humid environment. Additionally, the introduction of a flammable material, such as wood, warrants concerns of the possibility of a fire. As improbable as this may seem, precautions such as fire extinguishers should be considered and are included in the safety guidelines section.

Calculations performed for the construction of a walkway for the Mine Tunnel No. 1, based on a design shown in figure 20, indicate that approximately 2,500 pieces of 2-in by 6-in by 12-ft pressure-treated lumber would be required. The structure should be fastened with deck screws to minimize wood separation due to shrinkage.

The water in both mines may be minimized when the fallen material has been removed from the floor area and portal gates have been installed. The prevention of pooled water and the natural ventilation should evaporate any mine water. The portal systems have been designed to allow for drainage from the floor and increase the natural ventilation in the tunnels to assist with the evaporation process. If required, a gravel material can be placed in the low areas to prevent slippage and still allow natural drainage and evaporation of the water. The aggregate or gravel could also be used to make a walkway.

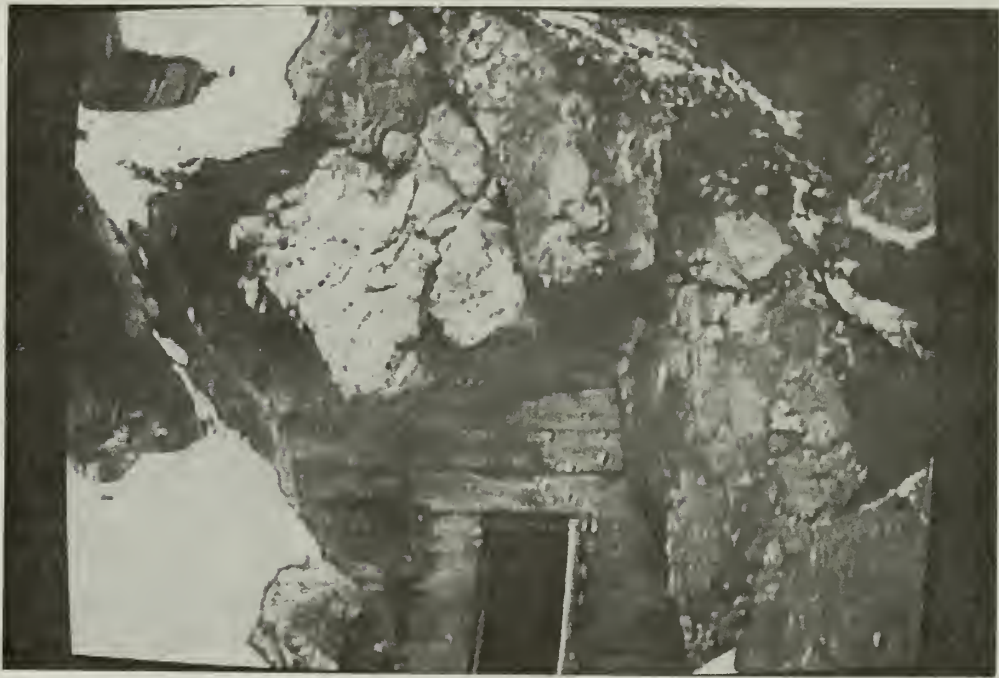
Photograph 2. The tree and root system above Mine Tunnel No. 2. Note the undermining of the rocks on the right at the portal caused by the surface drainage down a manmade trench (colonial period).

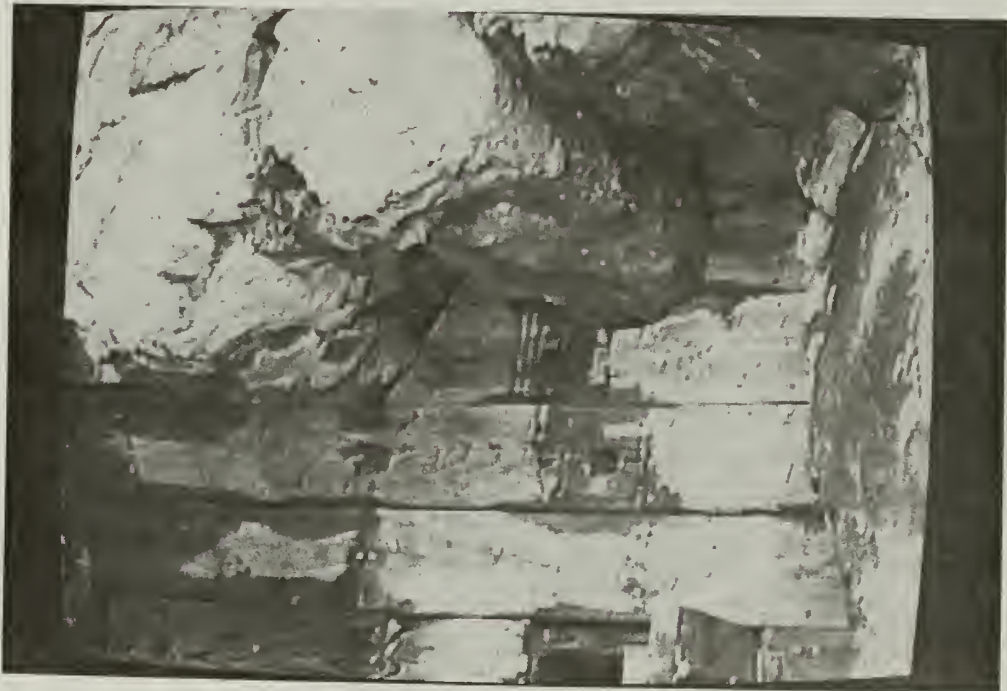
Photograph 4. The top portion of the portal door of Mine Tunnel No. 2. Note the wet condition of the wood which indicates run-off water at the portal area.

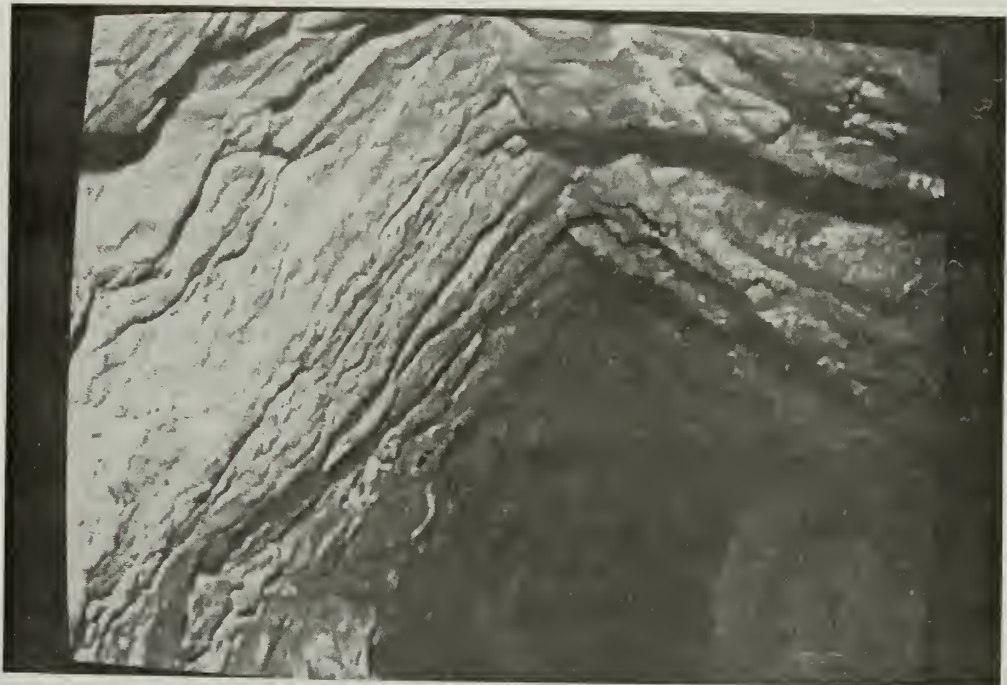
Photograph 7. The sidewalls and floor in Mine Tunnel No. 2. Note the small amount of material along the sidewalls.
